# Experimental and analytical investigation of dynamic crack patterns in automotive windshield sheets subjected to low velocity impact

P. Shojaei Shahmirzadi, H. Saeidi Googarchin\*

Automotive Fluids and Structures Analysis Research Laboratory, School of Automotive Engineering, Iran University of Science and Technology, Tehran 16846-13114, Iran

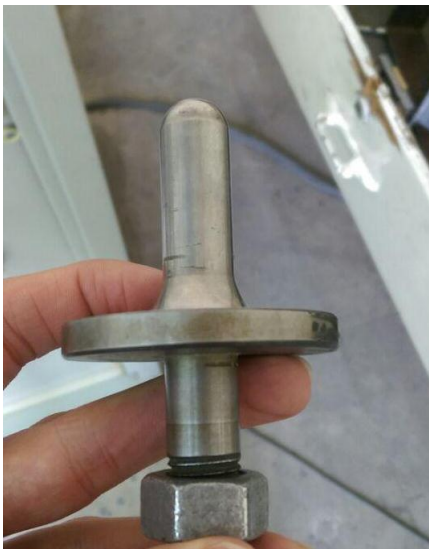
Fig2.Steel imp actor used in drop ball tests

The geometrical and mechanical properties of the impactor (which is depicted in Fig.2) are explained in Table 2.
