## Study of the effect on manufacturing parameters on the fatigue behavior of aluminum engine mounting bracket

The engine mounting bracket connects the engine to the car body and plays a key role in reducing vibrations and supporting the engine's weight and dynamic loads. It must be designed to withstand cyclic forces during normal use but fail safely in high-impact situations, like accidents, to minimize damage. This study examines how manufacturing parameters affect the fatigue performance of aluminum engine mounting brackets in cars. According to the staircase-Locati fatigue test results, the relative mean resistance load was measured at 1.24 with a relative scatter of 0.07, placing it in the unsafe operating region for the engine mounting bracket. To address this, a finite element analysis was carried out to identify critical areas on the part and implement modifications to enhance its performance. The crack initiation and growth regions observed during the fatigue tests aligned closely with the critical zones identified in the finite element analysis. Following the modifications and the removal of production defects, a series of experimental tests were conducted to assess the

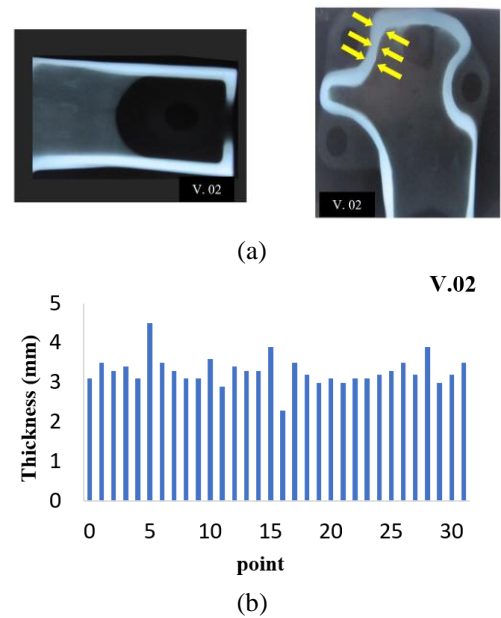
**Figure 10.** a) Radiographic image of the modified sample. b) Graph obtained from thickness measurement of the modified sample.

After examining the reasons for the failure of the samples in the high-cycle fatigue test, during the negotiations with the manufacturer, the manufacturing defects that led to the weakness of the part were removed, and the thickness in the critical area was increased by 20%. Before starting the fatigue test again on the modified sample, due to the high cost of the fatigue test, radiographic and thickness measurement tests were performed using non-destructive tests as shown in Figure 10.

Then it was found that the thickness in other places has increased by 9%, therefore, 2 grams have been added to the total weight of the secondary sample.
